**CWA COMPLIANCE EVALUATION INSPECTION REPORT
U.S. ENVIRONMENTAL PROTECTION AGENCY, REGION 5**

Purpose: Compliance Evaluation Inspection

Facility: Benton Dairy, LLC

Date of Inspection: April 28 and 29, 2021

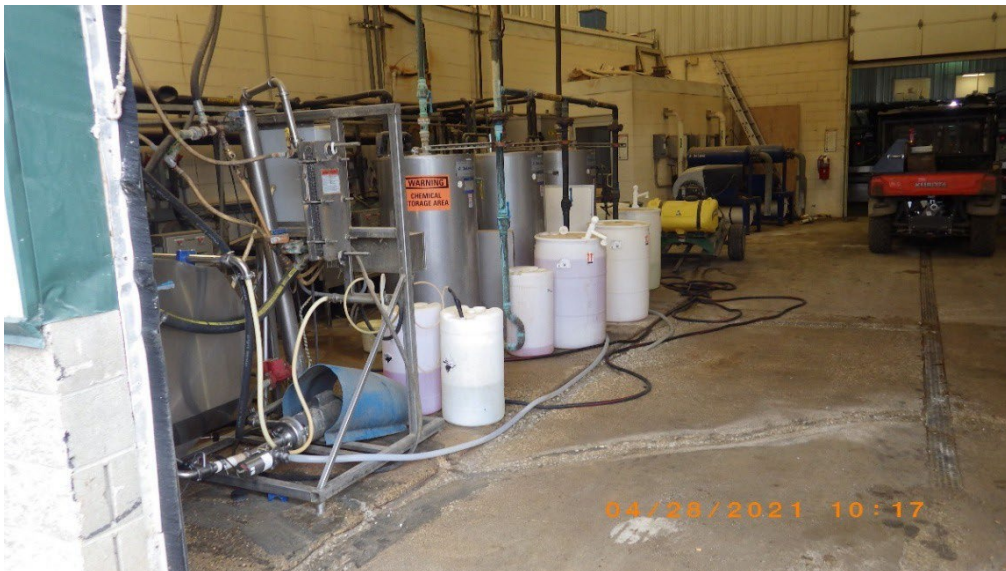
Photo Number: RIMG0067

We continued to the north side of the Milking Parlor where we observed the Chemical Storage Area. The Chemical Storage Area held teat dip, formaldehyde, and other chemicals. EPA observed drains in the Chemical Storage Area, which Mr. Benton explained would drain into the Sand Separation Lane (Photos RIMG0067 and RIMG0070) if there was a leak or spill from the chemicals. We continued to walk between Barn 2 and Barn 3 to the Recirculation Pit. The Milking Parlor has a drain that collects manure and process wastewater. The drain flows by gravity into the Recirculation Pit (Photo RIMG0071).

Description: The Chemical Storage Area has drains that convey flow to the Recirculation Pit between Barns 2 and 3.

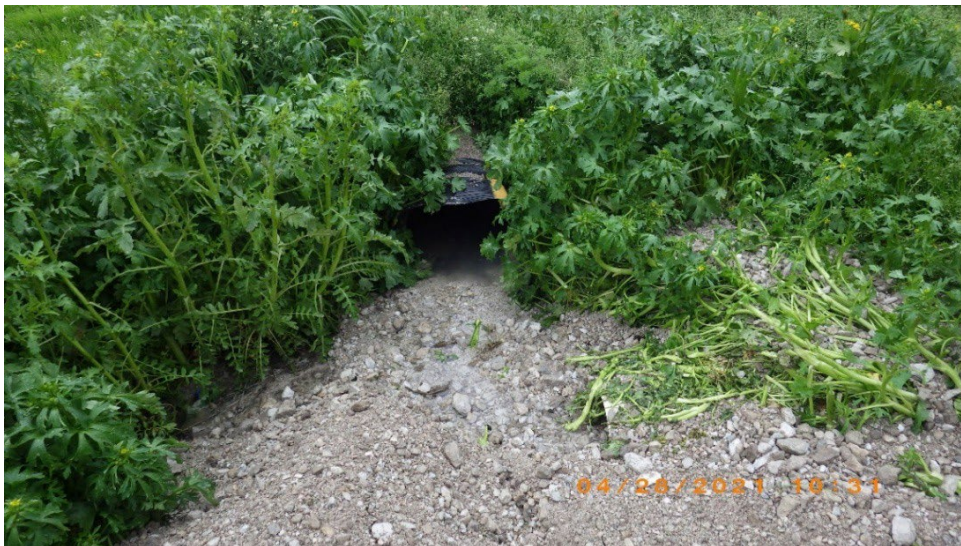
Photo Number: RIMG0074

Description: Drainage tile inlet between Barn 2 and Barn 3.

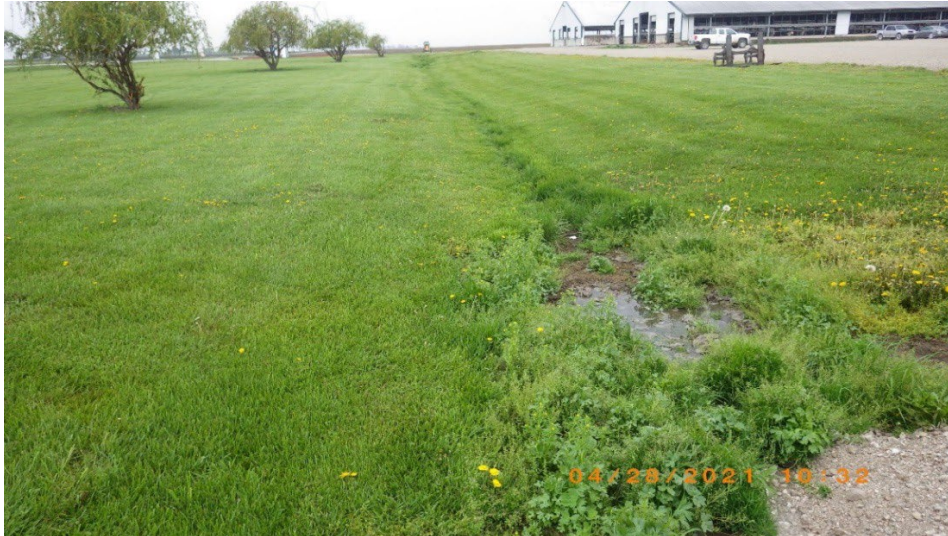
Photo Number: RIMG0075

Description: The drainage tile inlets collect the water between the barns and convey flow under the East Access Road into the East Drainage Channel identified above. The water within this East Drainage Channel will flow to the Stormwater Pond.

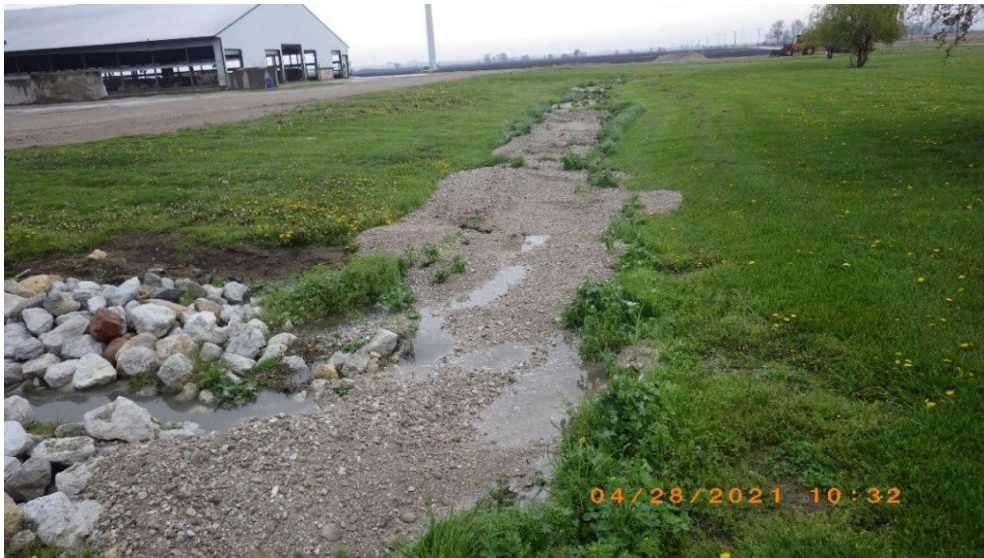
Photo Number: RIMG0077

Description: The drainage tile outlets into the East Drainage Channel.

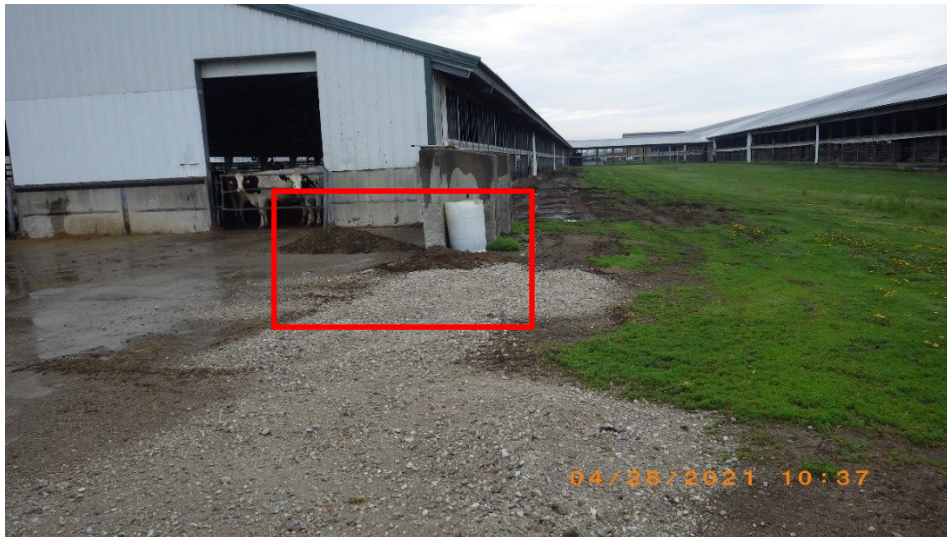
Photo Number: RIMG0078

Description: Used bedding that came out of Barn 2.

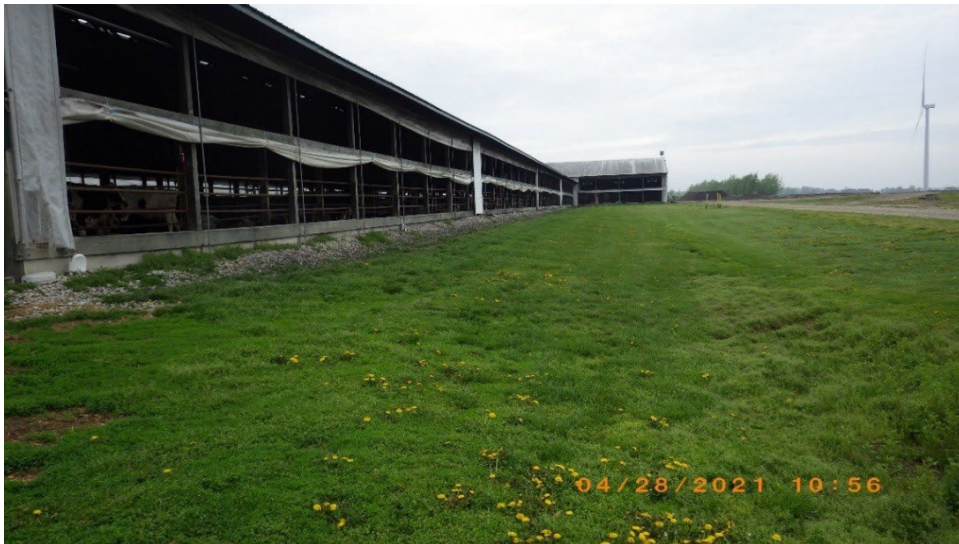
Photo Number: RIMG0084

Description: On the north side of Barn 1. The East Drainage Channel conveys flow to the north side of Barn 1, which eventually ends up in the Stormwater Pond.

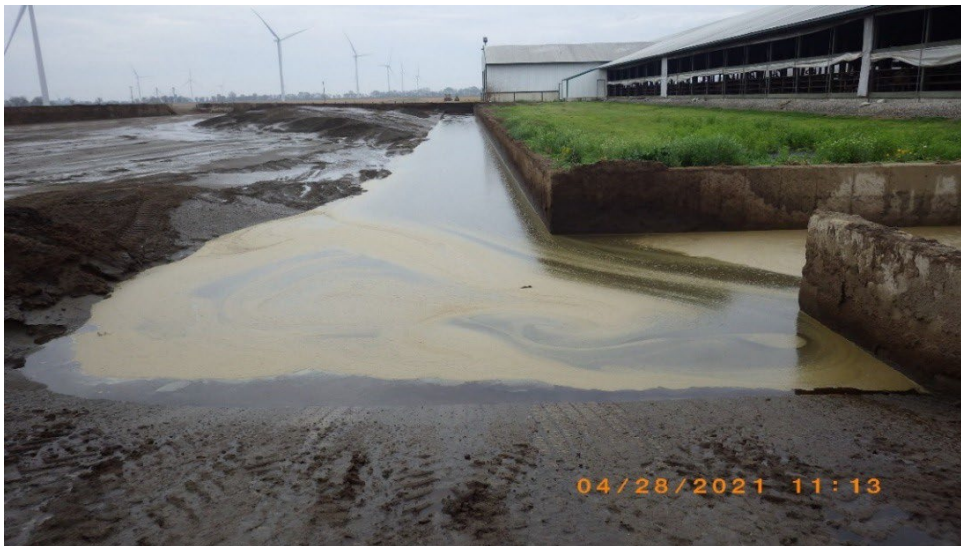
Photo Number: RIMG0095

EPA continued walking west on the north side of the facility and observed solids pushed over the concrete wall of the Solid and Sand Stacking Pad. ^{Ex. 6. (Personal Privacy)} explained that any stormwater that comes into contact with the solids been pushed over the wall would flow to the Stormwater Pond (Photo RIMG0091). We walked on the Solid and Sand Stacking Pad to observe how the process wastewater is pumped into the 1st Stage Lagoon (Photos RIMG0095 and RIMG0096).

Description: Sand Separation Lane which is pumped into the 1st Stage Lagoon.

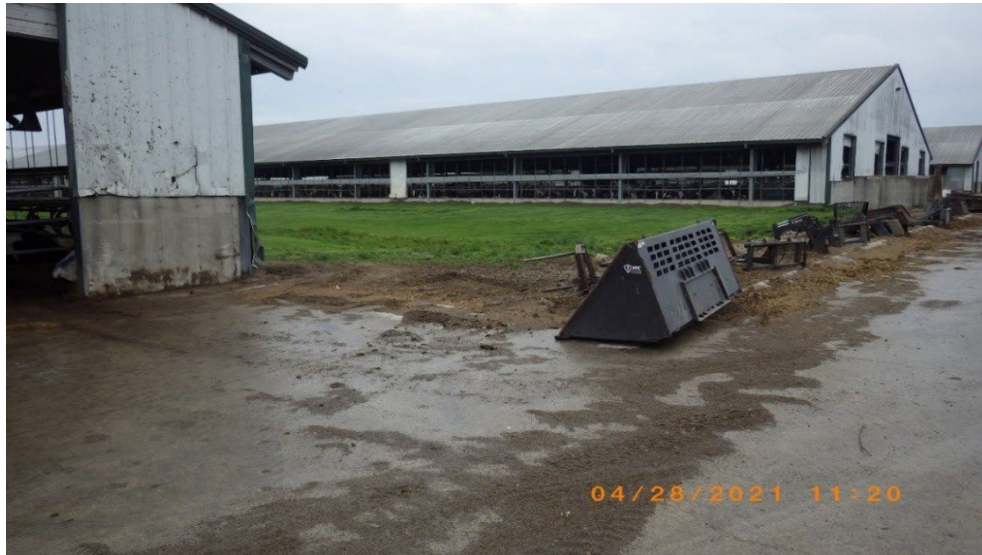
Photo Number: RIMG0102

Description: Used bedding and feed on the West Access Road between Barn 1 and Barn 2.

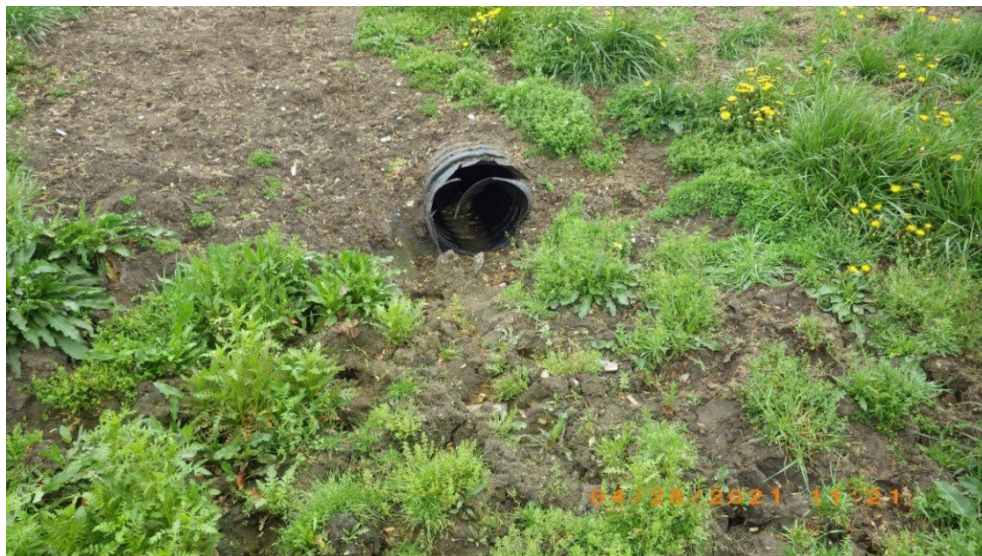
Photo Number: RIMG0103

Description: The drainage tile inlet between Barn 2 and Barn 3 on the west side of the Barns. The drain tile conveys flow between the barns to the Stormwater Pond.

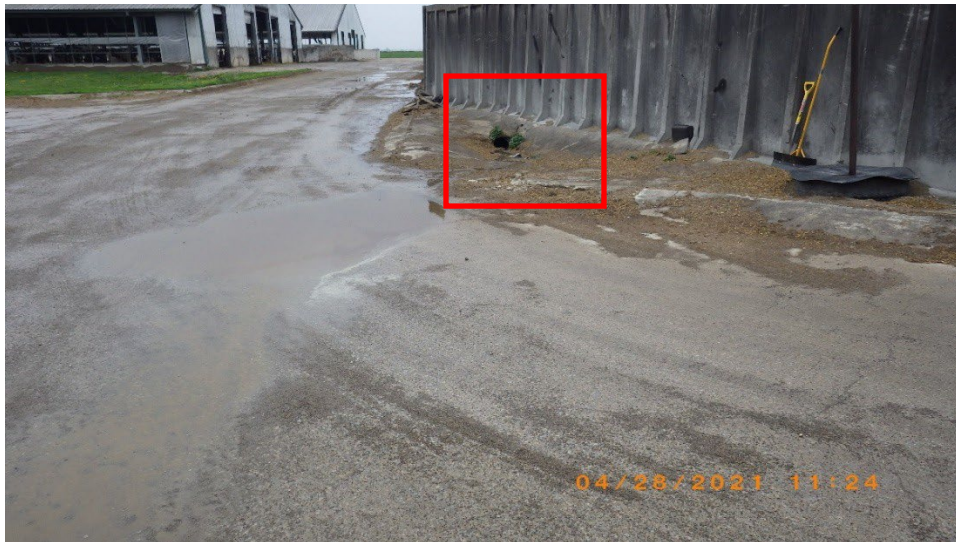
Photo Number: RIMG0106

Description: Stormwater mixed with used bedding and manure from Barns 1, 2, and 3 and feed on the West Access Road sloped to the southeast to drain into the tile inlet identified in the red outlined box.

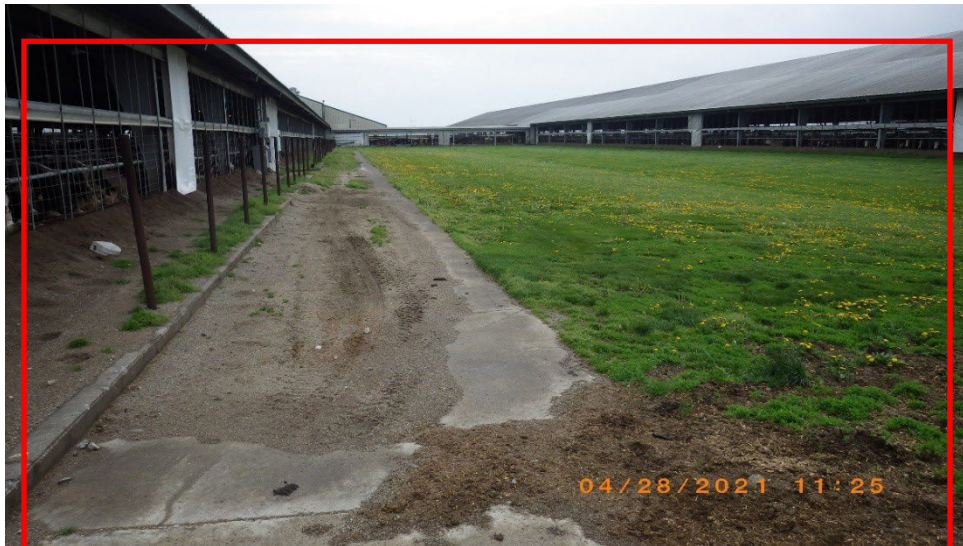
Photo Number: RIMG0108

Description: Looking between Barn 2 and Barn 3. Used bedding pushed out of the south side of Barn 3 shown in the red outlined box in the photo above.

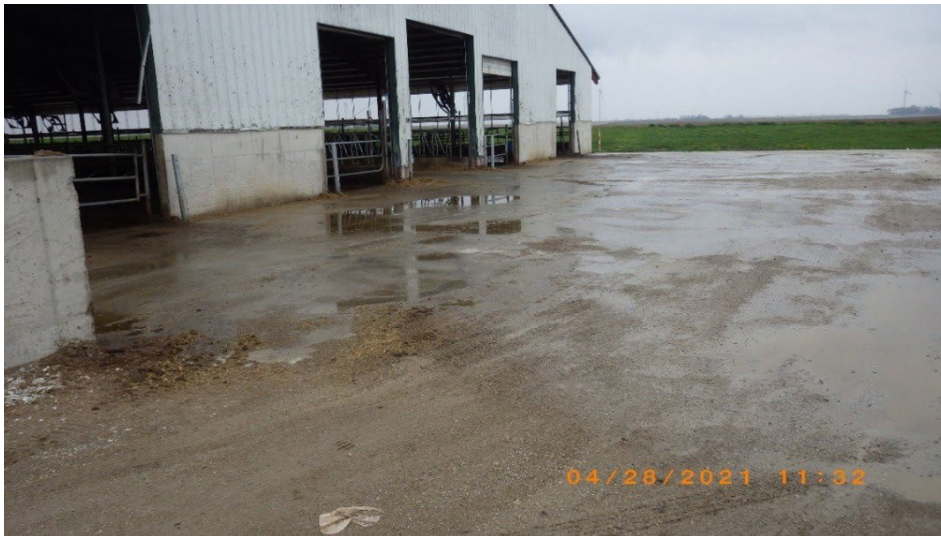
Photo Number: RIMG0115

We continued to the west side of the barns on the West Access Road (Attachment B). EPA observed the Hay Storage Barn on the west side of the facility and observed used bedding, feed, and manure on the West Access Road tracked out of Barn 1. (Photos RIMG0098 and RIMG0099). ^{Ex. 6. (Personal Privacy)} stated that any stormwater that comes into contact with solids tracked out of Barns 1, 2, or 3 flows either into the tile inlets between these barns or surface flows east along the West Access Road to the Solid and Sand Stacking Pad. ^{Ex. 6. (Personal Privacy)} stated that when stormwater comes into contact with solids on the West Access Road west of the Barn 4 and Barn 5, it surface flows to the South Drainage Ditch (Attachment B) and into the Stormwater Pond (Photos RIMG0115, RIMG0116, and RIMG0117).

Description: Used feed and bedding coming out of the doors on the west side of Barn 5 flows west into the Stormwater Pond.

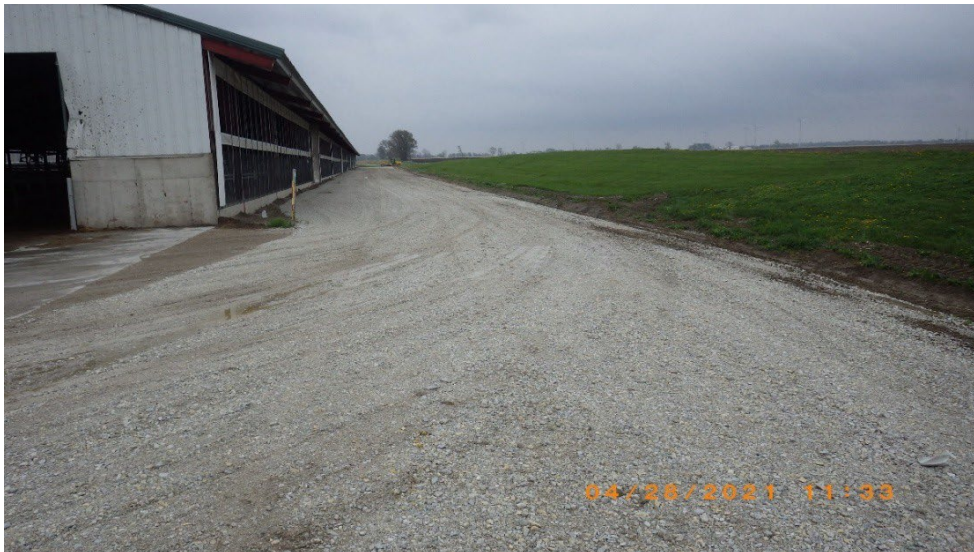
Photo Number: RIMG0116

Description: On the South Access Road on the south side of Barn 5.

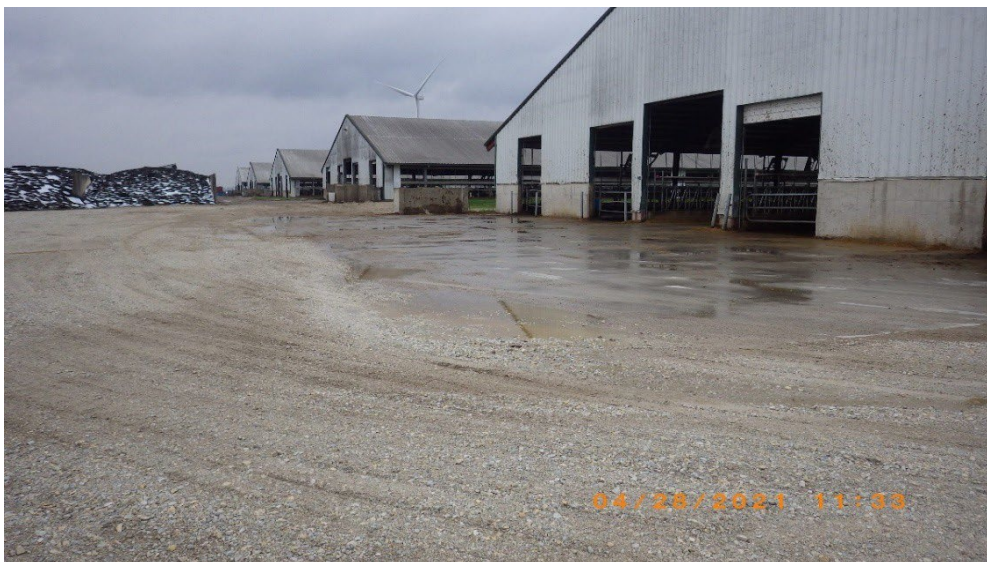
Photo Number: RIMG0117

Description: Observing the direction of flow on the west side of Barns 5 through 4, which is to the southwest.

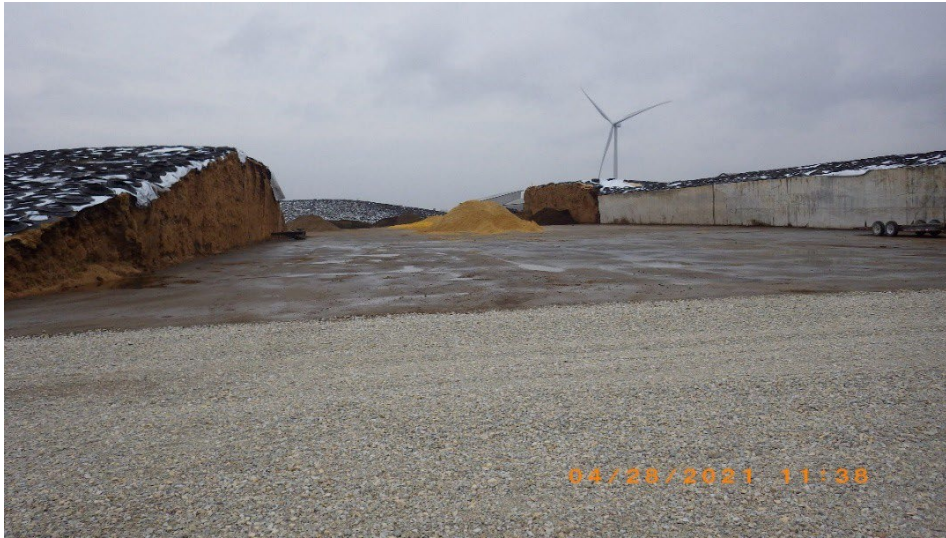
Photo Number: RIMG0120

Description: High grains stored in the concrete Feed storage Area that drain to the manholes that drain to the Silage Leachate Collection Pond.

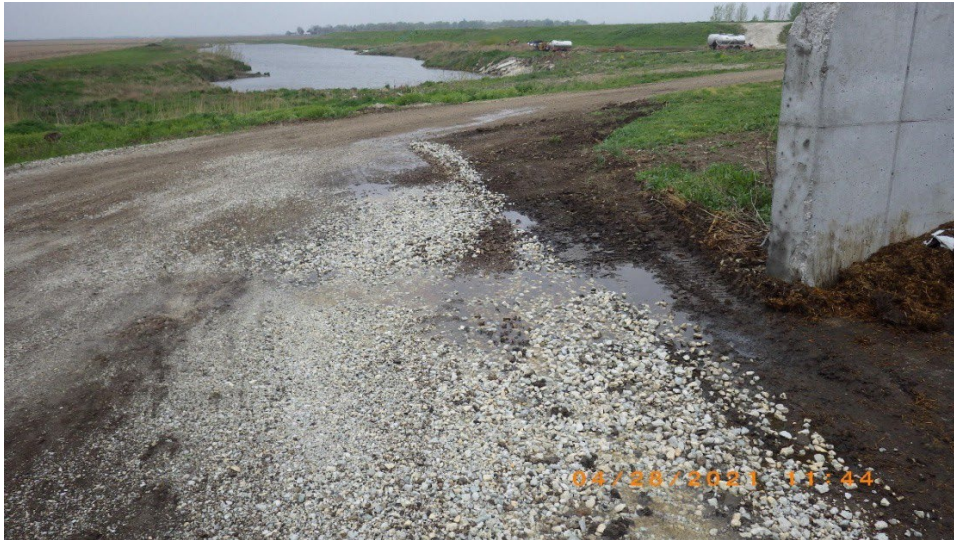
Photo Number: RIMG0124

We continued our walk-through to the south side of the Stormwater Pond and observed leachate from the silage stored in the silage bunkers. Any leachate, stormwater, and/or stormwater that comes into contact with the feed in the bunkers flows either into the South Drainage Ditch (Attachment B) or along the South Access Road (Attachment B) and into the Stormwater Pond (Photos RIMG0119 through RIMG0128).

Description: The process wastewater flowing to the south into the Stormwater Pond.

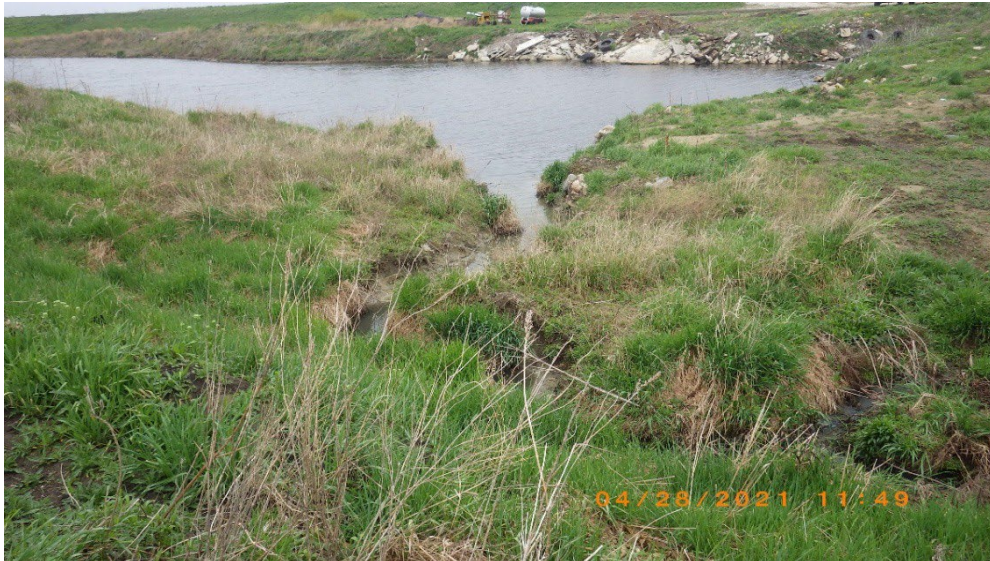
Photo Number: RIMG0128

Description: The eroded channel carries flow into the Stormwater Pond.

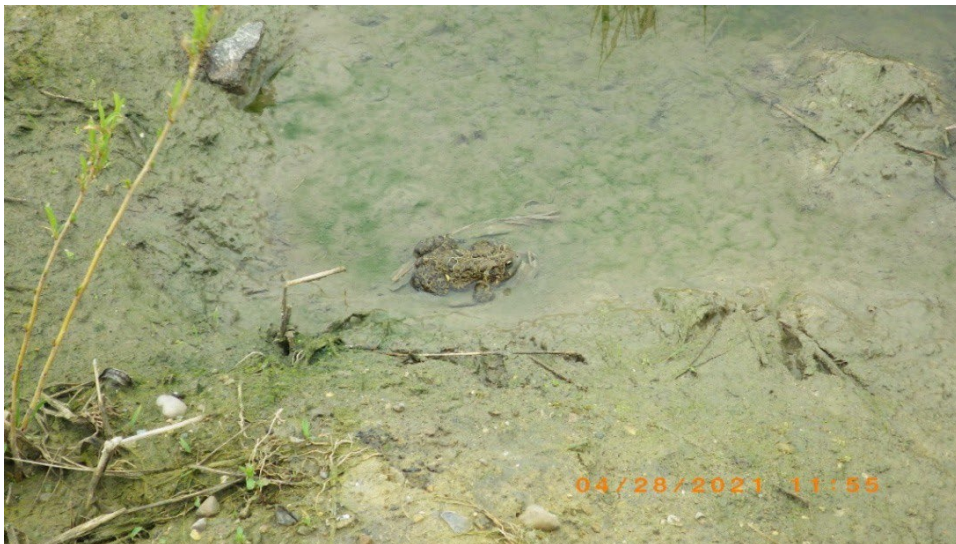
Photo Number: RIMG0129

As we were walking on the south side of the Stormwater Pond, we observed approximately one hundred frogs/toads within the Stormwater Pond (Photos RIMG0129 through RIMG0132). We continued to the southwest side of the Stormwater Pond where we observed the tile outlet into the Stormwater Pond. Mr. Boerman explained that the

Description: Observed hundreds of frogs in the Stormwater Pond.

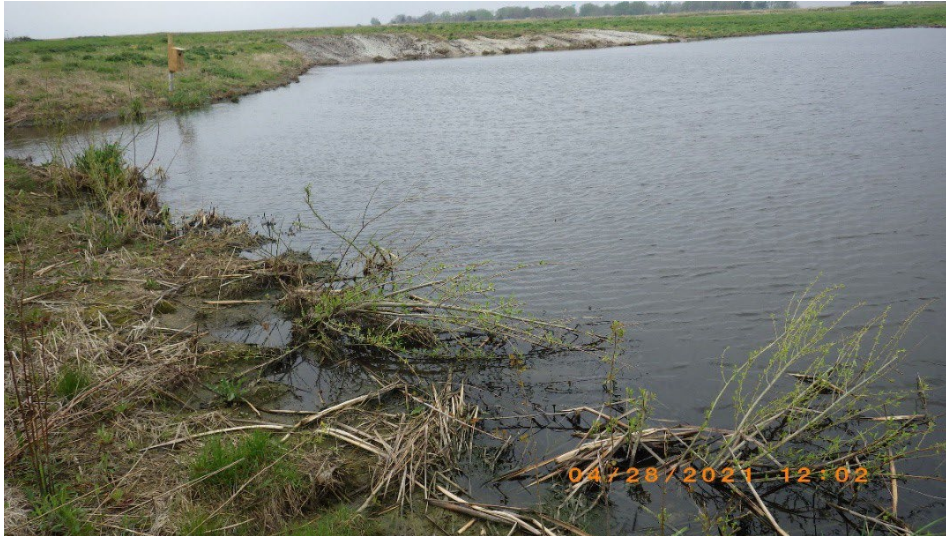
Photo Number: RIMG0130

Description: There were hundreds of frogs within the Stormwater Pond.

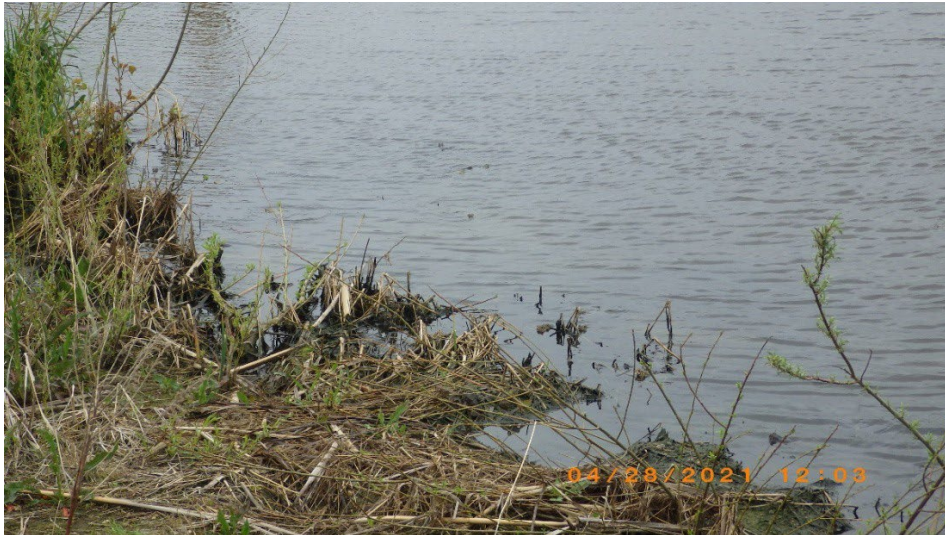
Photo Number: RIMG0132

Description: Again, frogs within the Stormwater Pond.

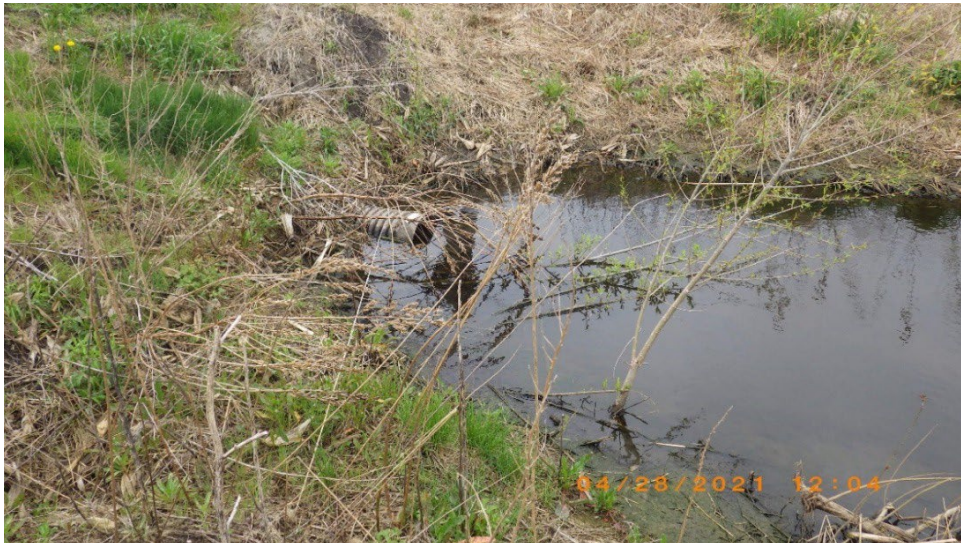
Photo Number: RIMG0133

agricultural field to the south was tiled to flow into Prudential Ditch (Photos RIMG0135 and RIMG0136), but this tile has been plugged and is now tiled to flow into the Stormwater Pond (Photo RIMG0133). We observed an access ramp into the Stormwater Pond, which Ex. 6 (Personal Privacy) explained farmers use to access the Stormwater Pond for irrigating their crops (Photo RIMG0134).

Description: Tile outlet from the agricultural field drains into the Stormwater Pond.

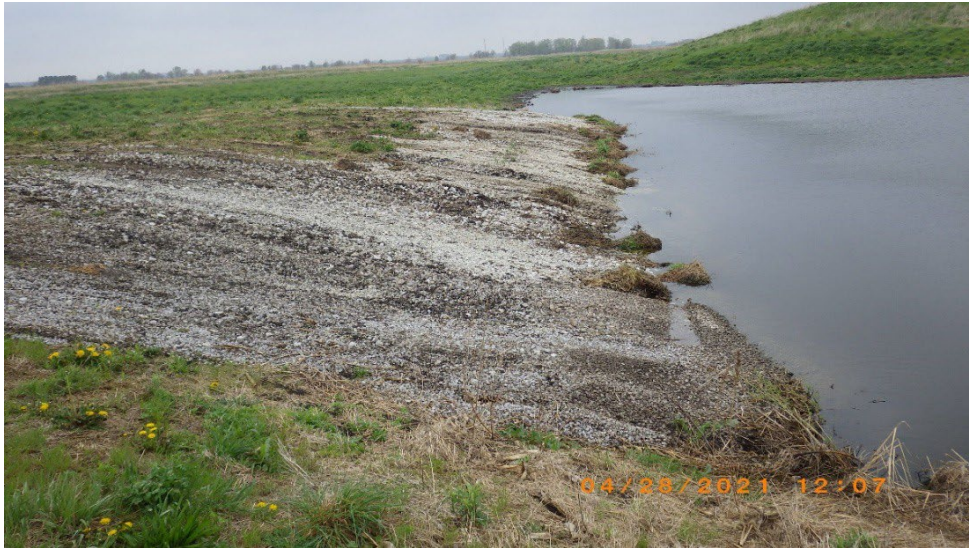
Photo Number: RIMG0134

Description: Access area to pump out the Stormwater Pond.

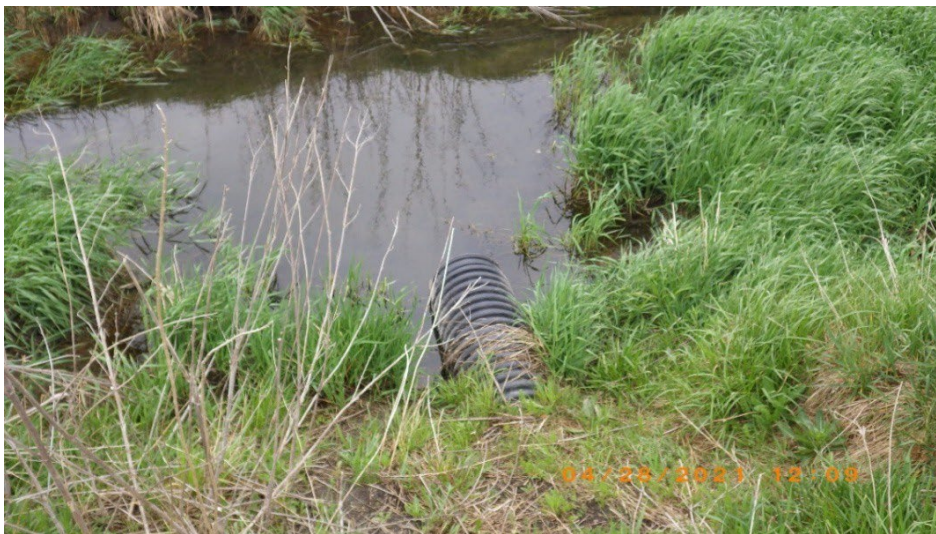
Photo Number: RIMG0135

Description: The drainage tile outlet into Prudential Ditch was plugged. The drainage has been rerouted into the Stormwater Pond.

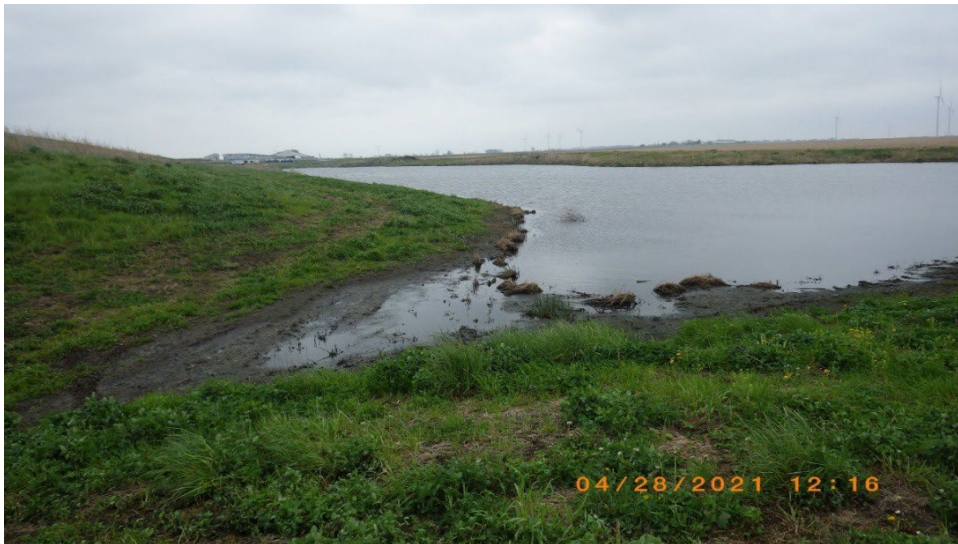
Photo Number: RIMG0138

Description: The flow drains from the north to the south into the Stormwater Pond.

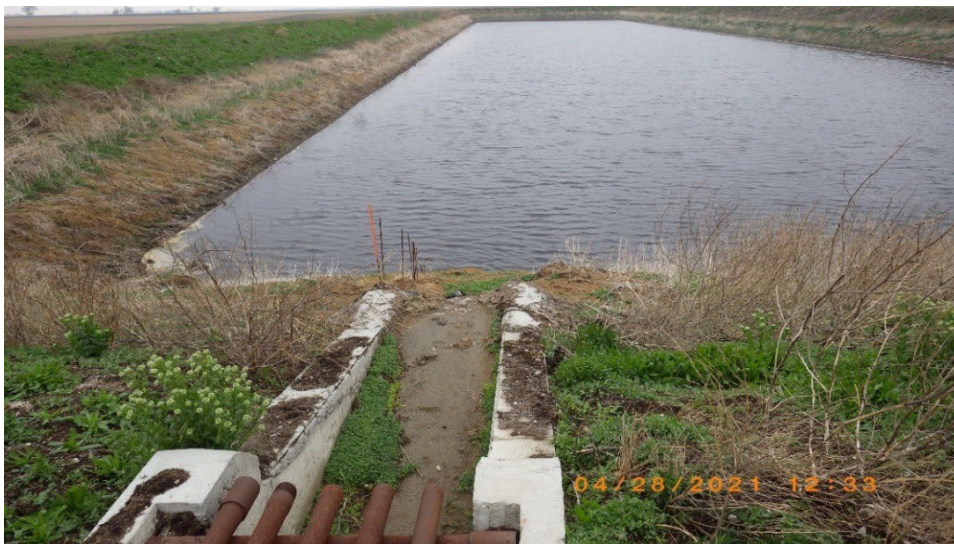
Photo Number: RIMG0143

We observed the concrete overflow between the 4th and 5th Stage Lagoon on the east side of the 5th Stage Lagoon (Photo RIMG0143). The concrete overflow works when the liquids reaches the height of the overflow, the liquids will gravity flow into the next stage lagoon, with less and less solids. We observed the depth marker within the 4th Stage Lagoon.

Description: The concrete overflow that conveys process wastewater from the 4th Stage Lagoon into the 5th Stage Lagoon.

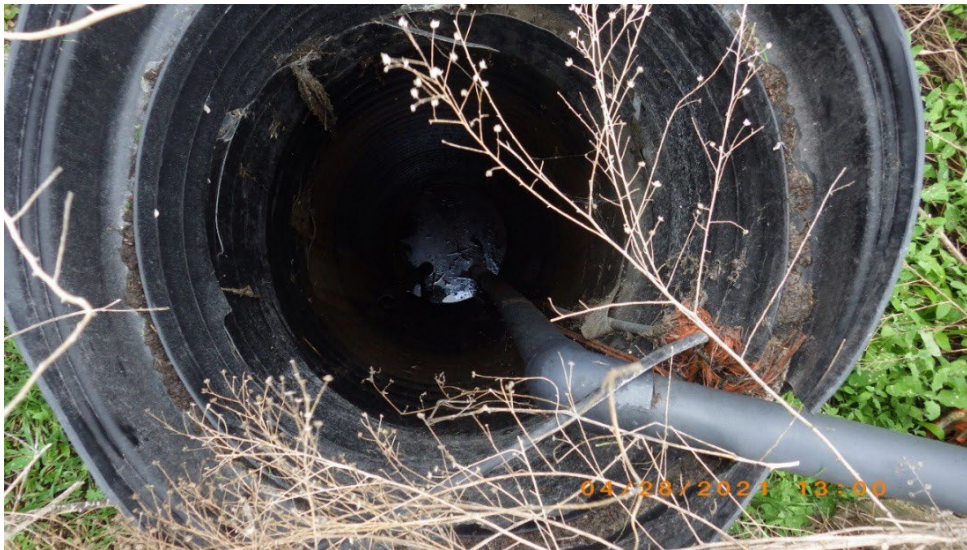
Photo Number: RIMG0169

Description: The perimeter tile pump into the Stormwater Pond.
